Field-Experience Based Root-Cause Analysis of Power-Converter Failure in Wind Turbines

Katharina Fischer, Thomas Stalin, Hans Ramberg, Jan Wenske, Göran Wetter,
Robert Karlsson and Torbjörn Thiringer, *Senior Member, IEEE*

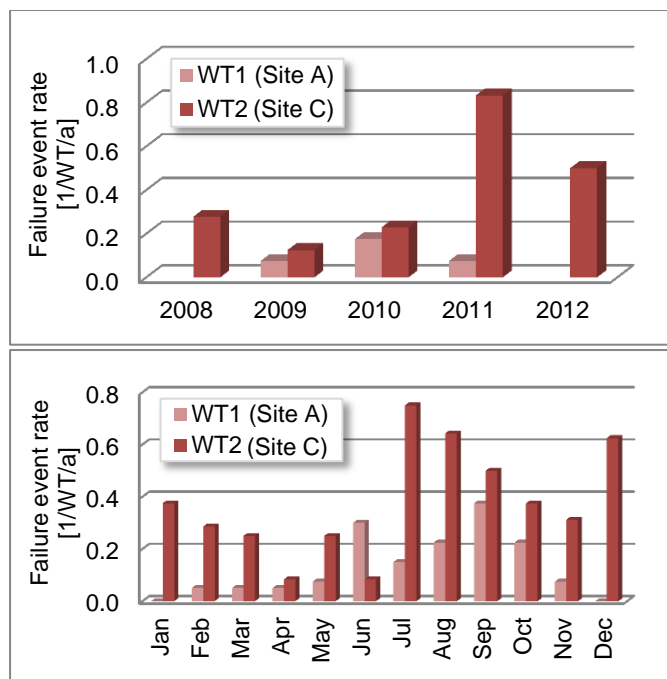
Fig. 3. Temporal distribution of converter failures in turbines of type WT1 (data from Site A, Jan. 2009 – Apr. 2011) and WT2 (data from Site C, Aug. 2008 – Feb. 2012)

The average annual converter failure rates are found to vary considerably over the years. While the period of observation is too short to identify possible age-related trends in the converter reliability, Fig. 3 reveals that the seasons summer and autumn are most critical with respect to converter failure at the sites considered.

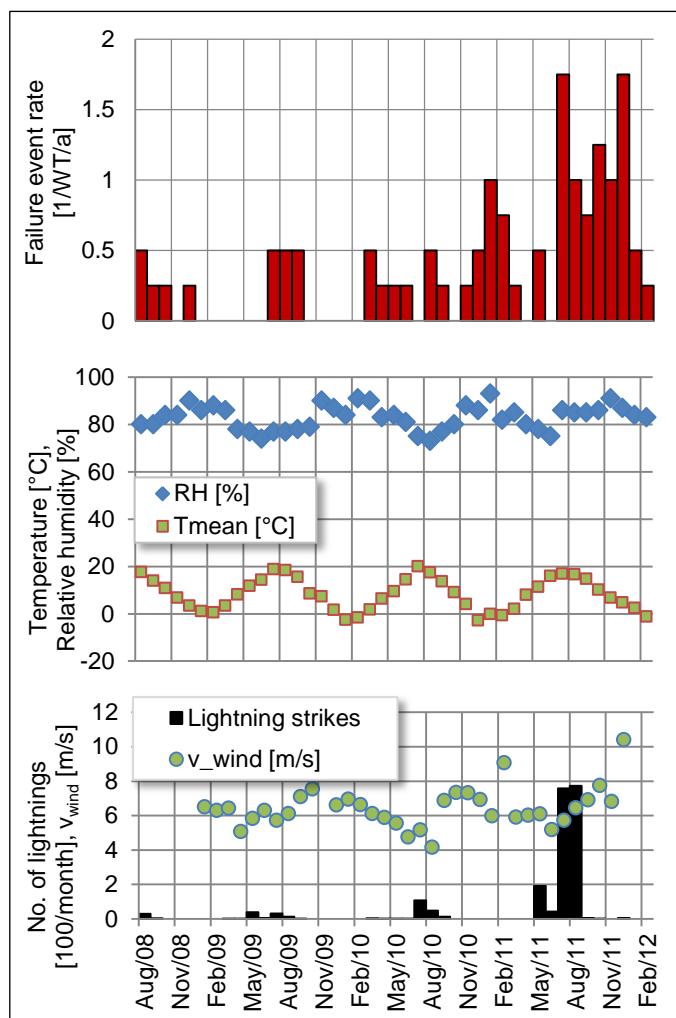
Fig. 4 shows the monthly number of converter failures together with the average values of the ambient temperature, the ambient relative humidity and the wind speed in the respective month. Not surprisingly, the average temperature is highest during the summer months, while the relative humidity reaches its maxima in the winter and wind speed reaches the highest average values in autumn and winter.

Fig. 4. Converter failures and monthly average values of ambient temperature, relative humidity, wind speed and number of lightning strikes at Site C

In order to further investigate the possible correlation of converter failure with lightning strikes, lightning data from Site C and its surrounding area has been analyzed together with the failure data. On an annual time scale, an extraordinarily high number of lightning strikes in 2011 coincides with a high number of converter failures in that year. In order to quantitatively assess the correlation between converter failure and lightning strikes, linear correlation analysis has been applied to the monthly numbers of converter failure and lightning strikes in vicinity of the wind park. The resulting correlation coefficient of $r = 0.48$ with $p = 0.001$ (see Table 3) confirms the visual impression of a strong correlation.

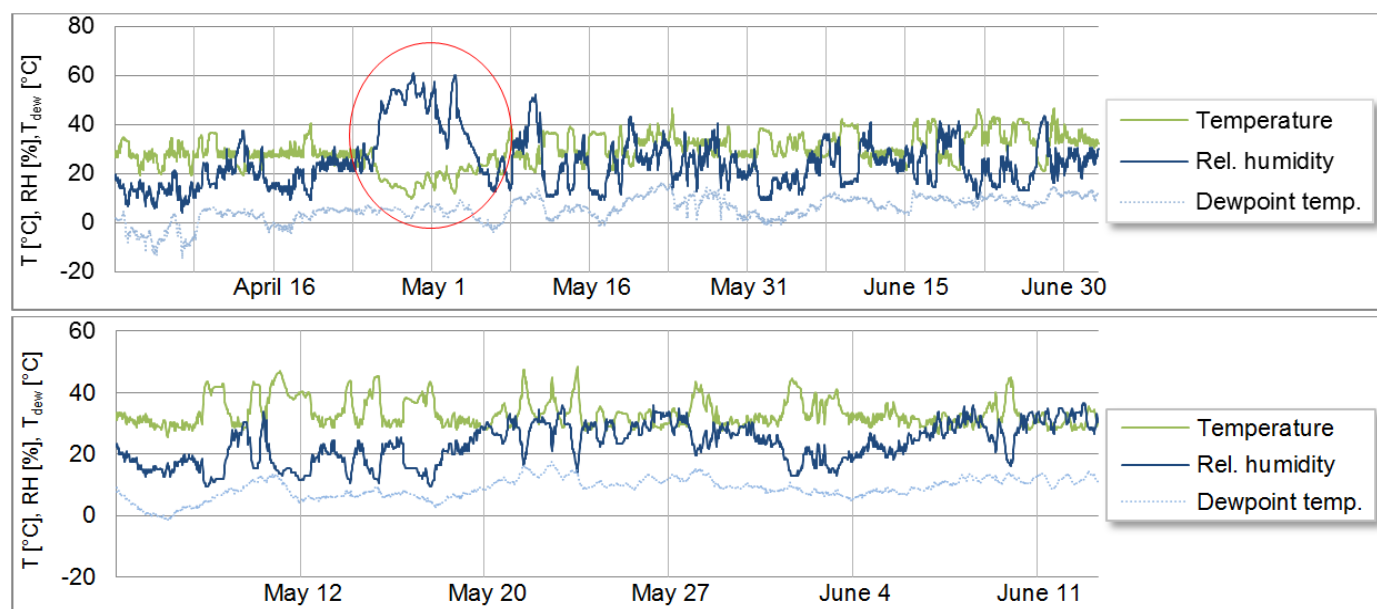
An interesting case could be logged on a WT1 turbine at the offshore Site A, see Fig. 5 during end of April and early May: After a standstill period of 9 days and 2 days of major repair work with an opened nacelle, a converter failure occurred during start-up of the turbine on 4 May. Similar cases were reported to have occurred before in the same offshore wind park. The logged temperature and relative-humidity data confirm that this most likely is related to condensation: Due to the standstill period, the nacelle cools down and the relative humidity increases to values of approx. 60%. This results in a low difference between the temperature logged at the top

inside of the converter cabinet and the corresponding dew-point temperature, which is likely to have caused condensation on the converter modules as these have a high thermal inertia.

In summary, it can be stated that the converter operating conditions are uncritical with respect to temperature and humidity during normal turbine operation but appear to be problematic with respect to condensation after long periods of standstill.

Fig. 5: Temperature, relative humidity and corresponding dew-point temperature inside the converter cabinet of a turbine of type WT1 (top, data from offshore Site A) and WT2 (bottom, data from offshore Site C)

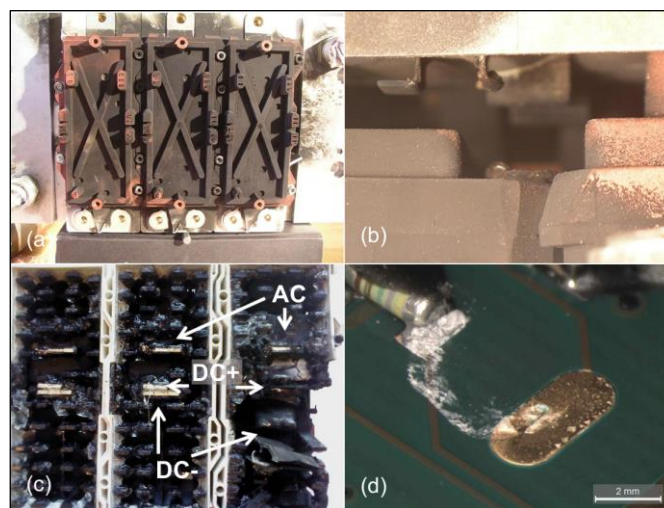
In the first investigated power module, denoted M1, evidence was found of high-voltage flashover between a cooling fin soldered to the gate-driver board and a screw fixing one of the half-bridges to the heat sink, see Fig. 6a and b. The dielectric strength of air is approx. 3kV/mm. Thus to initiate a flashover over a gap of 7 mm between the cooling fin and the screw, a voltage of approx. 20kV and therefore a multiple of the normal operating voltage of <1kV is required. The material transferred from the cooling fin to the screw indicates that the cooling fin must have been on a high negative potential with respect to the screw. Four possible scenarios that might have caused the observed damage were discussed:

- (1) A lightning strike hitting the surrounding structure found a discharge path through the converter module. The galvanic coupling between the power circuit and the cooling fin revealed by the electric measurements described in the previous section supports this scenario. A possible explanation is that the slip rings connecting the turbine shaft to the structure were not fully functioning.

- (2) A disturbance in the external grid occurred and the system failed to protect the IGBTs.
- (3) Static electricity build-up from the rotor blades of the turbine found a discharge path through the module. This phenomenon is known from airplane propellers and helicopters especially if rotor blades are of composite material. The energy involved in that case would be too low to cause the level of damage observed, but it might initiate an arc-flash event. Once an arc-flash event is initiated, a lower voltage level is sufficient to maintain it. A considerable amount of energy with the potential to cause the severe damage observed is typically available in the DC link of wind-turbine converters. However, static electricity build-up from the rotor blades is an unlikely cause of high voltages in the converter as an electricity build-up is usually drained through slip rings on the turbine shaft.

- (4) A reduction of the air gap by a foreign object could have started an arc flash, which subsequently might have been maintained in the way discussed above. A likely foreign object is e.g. an insect creeping into the open module. Bartram [25] showed that flies are attracted by the silicone gel typically covering the power-electronic devices in wind-turbine converters. In spite of the often large distances from the coast, large numbers of dead insects have been found inside the turbines and even inside the converter cabinets in one of the considered offshore wind parks (Site C), which makes the above a plausible explanation scenario.

Fig. 6. Signs of high-voltage flashover between a screw and a PCB cooling fin (a,b), melting pattern in module-internal busbars (c), contamination and corrosion products on a gate-driver board (d)

Not surprisingly, also the analysis of the second destroyed module, M2, has revealed signs of very high currents through the module. As Fig. 6c shows, all three paralleled half-bridges have the same damage pattern: The connections to the DC+ and the AC side show melting in the same contact points. The considerable displacement of the DC- connection from the DC+ connection observed in Fig. 6c gives evidence of a very strong energy release. Regarding the origin of this energy release, no clear evidence could be found. Among the potential mechanisms resulting in destruction is a resonance of the signal contact springs connecting PCB and IGBT gates. This might lead to intermittent loss of the contact between the gate-driver board and the IGBTs and therewith cause a so-called “floating gate” in the IGBT, i.e. a state between ON and OFF. A floating gate in an IGBT results in a strong heat-up and leads finally to thermal destruction.

An irregularity discovered in module M2 were corroded spots at the bottom side of the DCB as well as on the upper side of the non-anodized aluminium heat sink. In the area of these spots, no thermal grease was found left between the two surfaces and the inert gold-layer covering the bottom side of the DCB was damaged. SEM/EDS analysis of one of the spots showed that it predominantly consists of aluminium and copper, i.e. of material from the heat sink and the DCB. No traces of chlorine were found, which could have pointed to the ingress of salt. The positions of the spots coincide with the points in which the DCB is pressed to the heat sink by means of the plastic pins visible in Fig. 6c. In combination with the chemical composition of the spot, this observation strongly suggests the presence of fretting: Under the impact of mechanical pressure, thermal cycling and possibly also promoted by vibration, abrasive wear of the two surfaces takes place. The craters caused by this effect were found to reach no further than approx. 75µm over and into the DCB surface, which is not considered critical for the integrity of the DCB. An interesting question requiring further investigation is if the fretting spots are afflicted with an increased thermal

The key finding in module M3, which also constitutes a possible failure cause, was the observation of contamination spots and likely corrosion products at several positions on the PCB, see Fig. 6d. A SEM/EDS analysis of the contamination revealed the presence of sodium and chloride, indicating impact from the sea based environment, i.e. moisture and salt.

The SEM/EDS analysis of the contamination observed between a component pad and a connector pad showed a dominant content of tin, chloride and oxygen, which points to corrosion products. These have formed a possible path for electrical (ionic) conduction during field operation.

In the context of the described flashover damage, the air gap between the cooling fin and the screw is regarded relatively small. Besides using a design with a larger air gap, a measure to prevent flashover in this part of the module could be the

introduction of a thin insulating sheet of e.g. Kapton or Mica in the gap.

resistance, as only in that case, it would be considered a reliability-critical phenomenon. Possible countermeasure concerning the formation of the observed spots could be the anodizing or the creation of a finer structure of the heat-sink surface. An additional observation made in module M2, but also in several non-destructed modules was a deterioration of the thermal grease between the DCB and the heat sink: This appeared to be relatively dry and seemed to have been applied in relatively small amounts, not completely covering the interface area of the DCB and the heat sink. A deterioration of the thermal grease can cause an increase in the thermal resistance to the heat sink and might in this way lead to overheating or accelerated aging of the power devices.

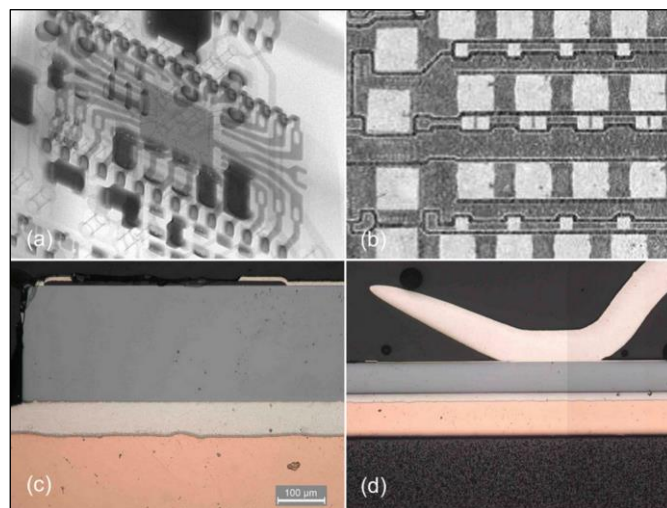
Also in case of module M4, the damage was found to be located on the PCB: Optical inspection revealed re-melted solder joints in addition to a burned MELF (Metal Electrode Leadless Face) resistor. An X-ray inspection of this area showed that also on the upper, moulded side of the driver board, joints were re-melted. Additional X-ray inspection of the driver board did not reveal any further damages or discrepancies of PCB components or solder joints.

Fig. 7b shows an image from SAM analysis of the die-attach solder of the IGBT and diode chips of a half-bridge in converter module M3. The SAM analysis showed similar acoustic signal response from all chips in the half-bridges of both M3 and M4, indicating intact die attach solder in all chips.

Fig. 7: X-ray inspection of driver-board solder-joints (a), graphical representation (excerpt) of scanning-acoustic-microscopy signal from die-attach solder of IGBT and diode chips (b), cross-section inspection of die-attach solder (c) and bond-wire attachment to chip (d)

Finally, the results of the SAM analysis and the bond-wire pull test have been verified by means of microsectioning and cross-section inspection of two IGBT chips. Fig. 7c and d show optical microscopy cross-section images of an IGBT chip from a half-bridge in converter module M4. The cross-section inspections revealed intact die-attach solder without any signs of crack initiation. The bond-wire connections showed largely satisfactory attachment, apart from small crevices at the bond-wire heel. This could be the initial stage of a fatigue crack, but could also have been caused by a not fully melted bond zone during the wire-bonding operation.

In total, the cross-section inspection supports the observations from the manual pull test of the bond wires and the SAM analysis of the die-attach solder, according to which the observed module failure was neither caused by poor solder-joint quality nor by bond-wire damage.
