6th Workshop on Metallization and Interconnection for Crystalline Silicon Solar Cells, 2016

Silver grid finger corrosion on snail track affected PV modules - investigation on degradation products and mechanisms

Ines Duerr^{*a}, Joerg Bierbaum^a, Jens Metzger^a, Jannik Richter^a, Daniel Philipp^a

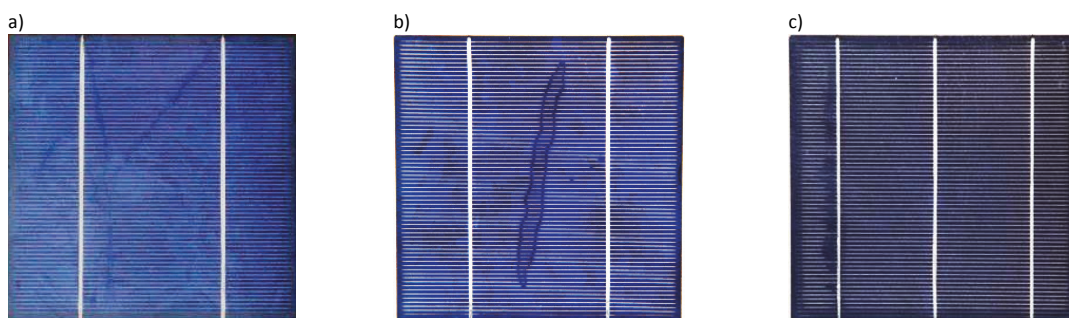
The thesis of diffusing reactants is supported by a second phenomenon which affects the silver grid fingers at the cell edges and is named “framing” due to its visual appearance (see Fig 1b + c). For field failed PV modules, it is often observed that the degradation products of framing and snail tracks differ or that no framing is observed even when snail tracks are present. Therefore, one of the most interesting tasks next to finding the root causes of the single degradation products is to investigate the difference between framing and snail tracks in terms of reaction conditions.

Snail tracks can strongly differ in terms of visual appearance in the PV module. In addition to the differentiation done before (framing vs. snail tracks, see section 4.1), also the single snail track phenomena can show different characteristics. Snail tracks occur single lined (see Fig 1a), double lined, worm-like (see Fig 1b) or even more extensively (see Fig 1c).

Fig 1 Visually different snail track discolorations; (a) single lined, (b) double lined and (c) extensive discoloration.

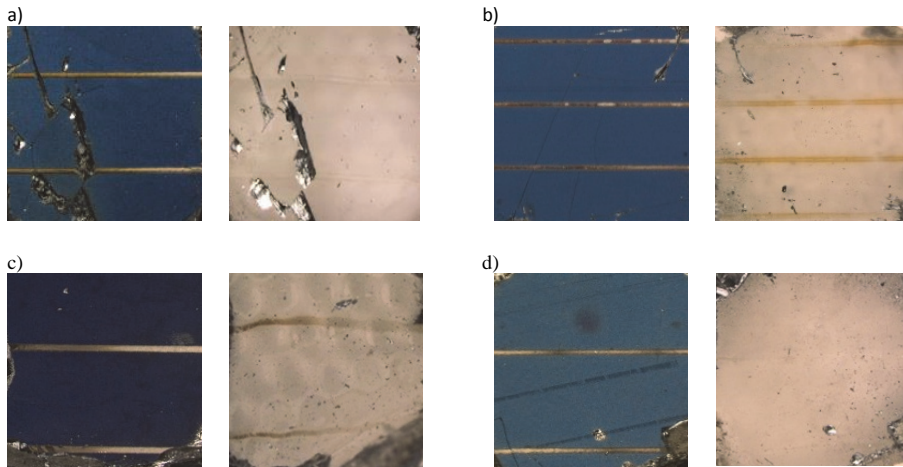
As described in section 2.3., a destructive sample preparation has to be done in order to get cell samples for the subsequent degradation product determination. After preparation, an additional differentiation of visual appearance of the single snail track types could be observed (see Fig 2). For two types of snail tracks (a and d), the silver grid fingers show a strong discoloration while the corresponding EVA material from the front of the cell does not show any discoloration on top or inside the material. The other two types of snail tracks showed a completely different behavior; both the silver grid finger and the EVA material show strong discoloration (see Fig 2b and c).

Fig 2 Cell and EVA sample from module affected with (a) silver carbonate and (b) silver acetate, (c) silver phosphate and (d) silver sulfide snail tracks.

In Fig 2a it is shown that the EVA material above the silver carbonate affected cells does not show any discoloration. This indicates that the encapsulation material is not directly correlated to this kind of snail track and therefore this effect can be observed for all types of encapsulation (not limited to EVA material). The reaction forming silver carbonate snail tracks is dependent on the metallization composition of the grid finger surface (presence of ZnO), the carbon dioxide and water vapor diffusion property of the back sheet material and the presence of UV irradiation.

Looking at the extracted cell and EVA samples from silver phosphate snail track affected PV modules, it can be seen that the EVA material from the top of the affected grid fingers shows significant discoloration (see Fig 2c). This supports our thesis well that the EVA material or every other encapsulation material including phosphorus-containing antioxidants directly contribute to this reaction and therefore show also a discoloration.

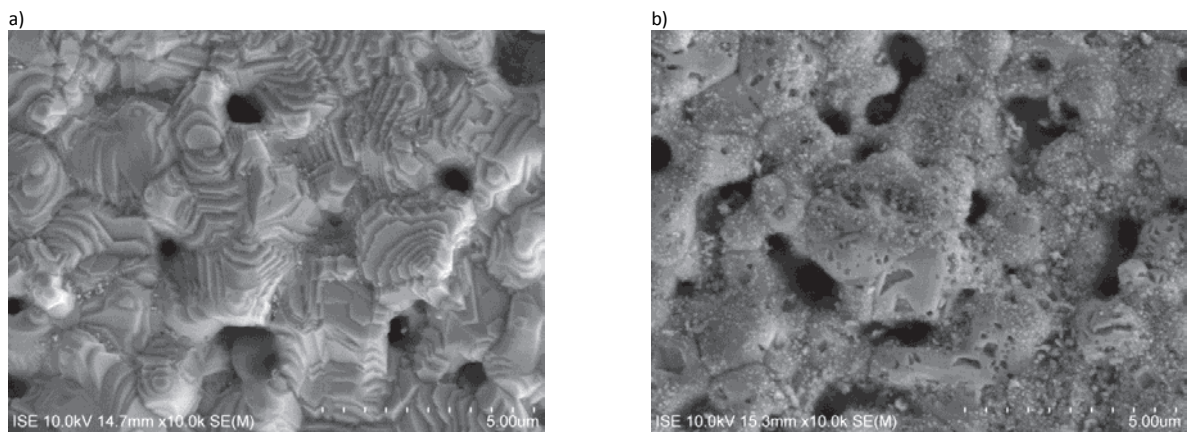
The discoloration which can be seen on the silver grid finger is mainly contributed by small silver salt precipitates on the grid finger surface, which is exemplarily visualized for a silver acetate snail track type by Scanning Electron Microscopy (SEM) in Fig 3b. In addition, the degraded surface shows a significantly increased surface roughness in comparison to the reference grid finger surface (see SEM image of reference grid finger surface Fig 3a), which contributes to the visual discoloration as well.

Fig 3 SEM image of reference (a) and snail track affected (b) silver metallization grid finger surface.

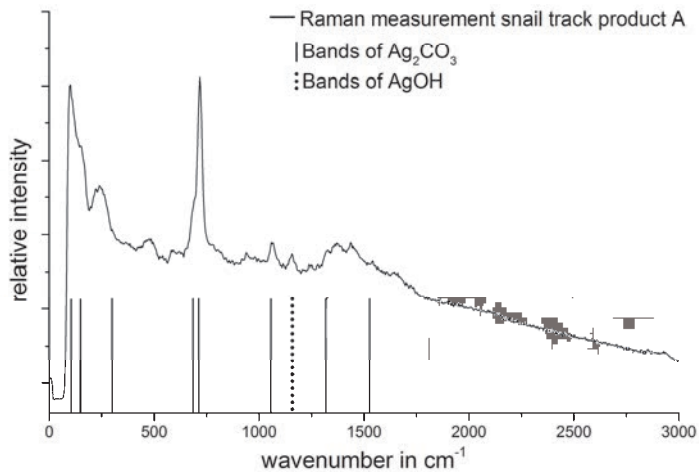
Referring to Fig 2, on the cell sample (a) silver carbonate was detected on the discolored silver grid finger. The Raman measurement together with the bands measured from the reference material of silver carbonate is shown in Fig 4. In addition to silver carbonate (Ag_2CO_3), silver hydroxide (AgOH) may be detected as a second phase, which indicates the formation reaction reported in literature [9], resulting in a basic silver carbonate.

Fig 4 Raman spectrum of degradation product A at low laser intensity with the main vibrations assigned and the bands given from the silver carbonate reference sample.

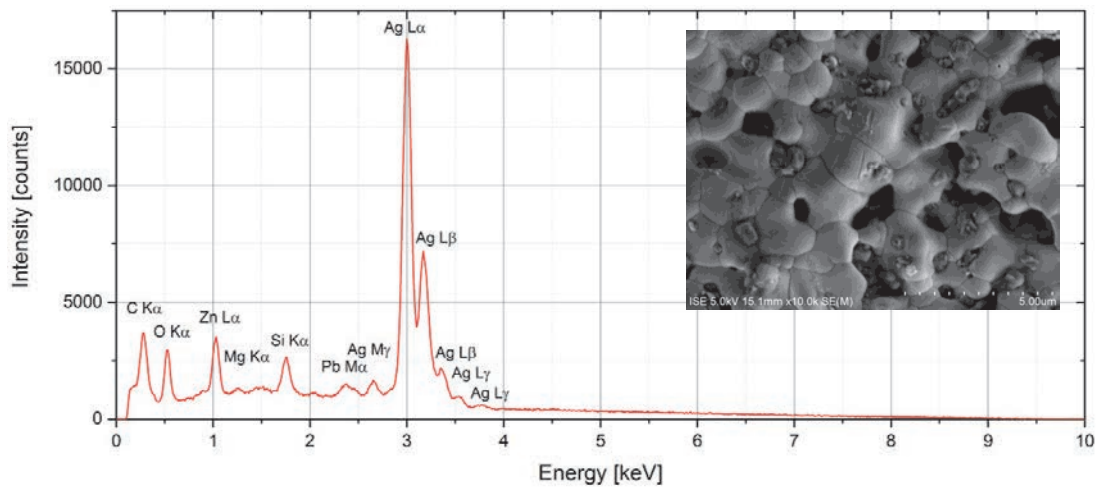
A good explanation for the ZnO -supported reaction mechanism of silver carbonate is found by Freund *et al.* [10], where a metal oxide supported adsorption of the carbon dioxide on the silver surface is detected. ZnO is a common glass additive used in most of the standard screen printing metallization pastes for c-Si cells, besides other metal oxides for the contact formation as e.g. lead oxide. Normally, the metal oxide containing glass additive melts during the firing process of the screen printed paste accompanied by a reduction of the metal oxides caused by the reductive atmosphere.

Fig 5 EDX measurement and SEM image of silver carbonate affected cell showing zinc carbon, oxygen, lead, silicon, magnesium and silver.

The theory of the present ZnO supporting the CO₂ adsorption on the silver grid finger, and therefore coordinating the carbonate together with the silver, could additionally explain the slight shifts in the Raman bands in comparison to the bands of the reference, Ag₂CO₃, spectrum.

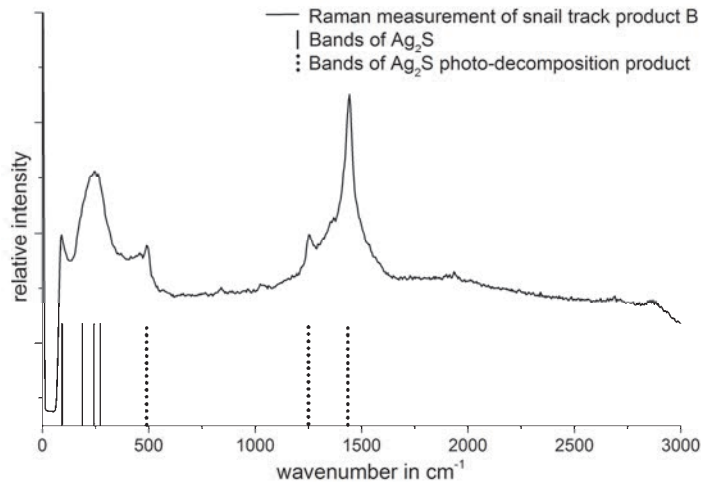
Fig 6 Raman spectrum of degradation product B at low laser intensity with the main vibrations assigned and the bands given from the silver sulfide and its photo-decomposition product.

The Raman spectrum of the degradation product measured on the affected silver grid finger, the reference bands of silver sulfide and additional bands of a silver sulfide decomposition product [15] are shown in Fig 6. It shows that the main vibrations assigned to the degradation product silver sulfide, measured at low laser intensity, are in good agreement with the bands given from the silver sulfide reference and its photo-decomposition product.

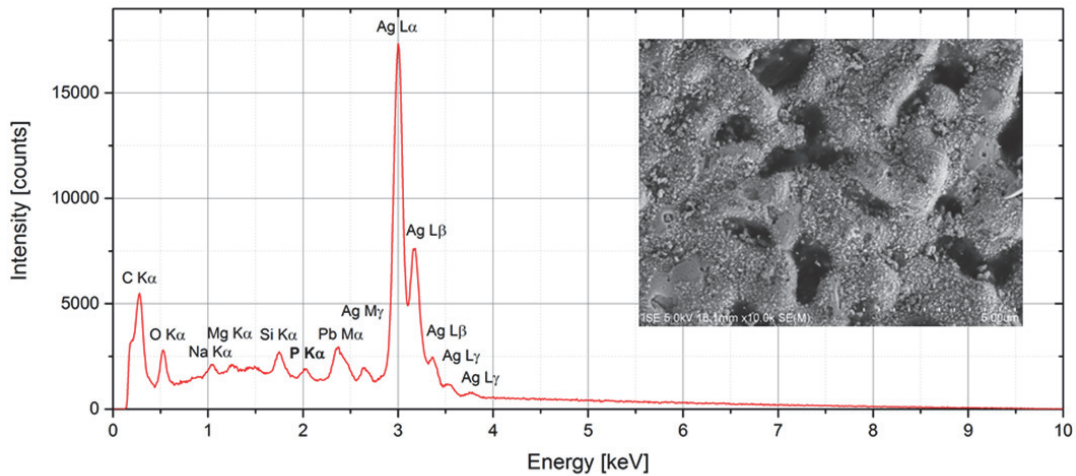
From literature, it is known that phosphorus-containing additives (phosphite or phosphonite compounds) used as secondary antioxidants are often utilized as stabilizer against peroxide degradation in encapsulation materials. In contrast to the sulfur-containing antioxidants discussed before, these additives are used mainly for process stabilization. Therefore, the influence on long-term stability is limited, since the hydrolysis or oxidation reactions easily transform the compounds into the corresponding acids or phosphates [11]. These phosphates are then likely to form silver phosphate on the silver grid finger when oxygen and humidity is present.

Fig 7 EDX measurement and SEM image of silver phosphate affected cell phosphorus, carbon, lead, silicon, silver and sodium, magnesium and aluminium most likely as counter ions.

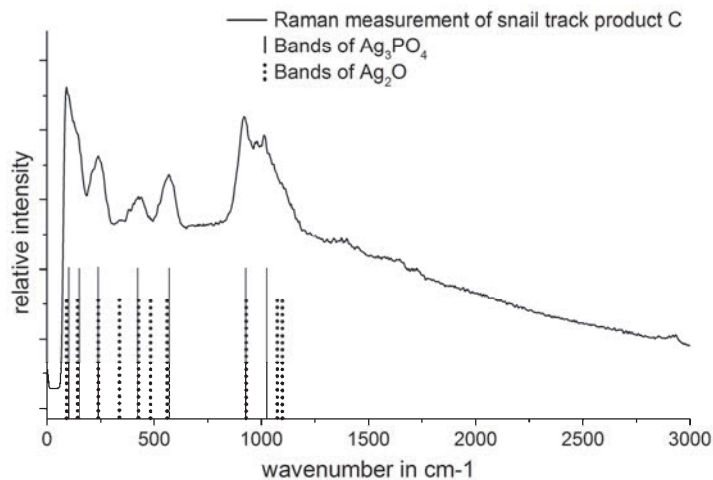
Referring to Fig 2, on the sample (c) silver phosphate was detected on the discolored silver grid finger. The Raman spectroscopic measurement of the degradation product found on the affected silver grid finger and the corresponding reference peaks (data from [15]) can be seen in Fig 8. Two different sets of reference bands and therefore degradation products could match. On the one hand silver phosphate (Ag_3PO_4) and on the other hand silver oxide (Ag_2O) (see Fig 8) [9,15,17]. EDX measurements on the affected silver grid finger showed the presence of phosphorus (P) (see Fig 7), so that we conclude that silver phosphate is the right assignment to this snail track type.

Fig 8 Raman spectrum of degradation product C at low laser intensity with the main vibrations assigned and the bands given from the silver phosphate or silver oxide reference spectra.

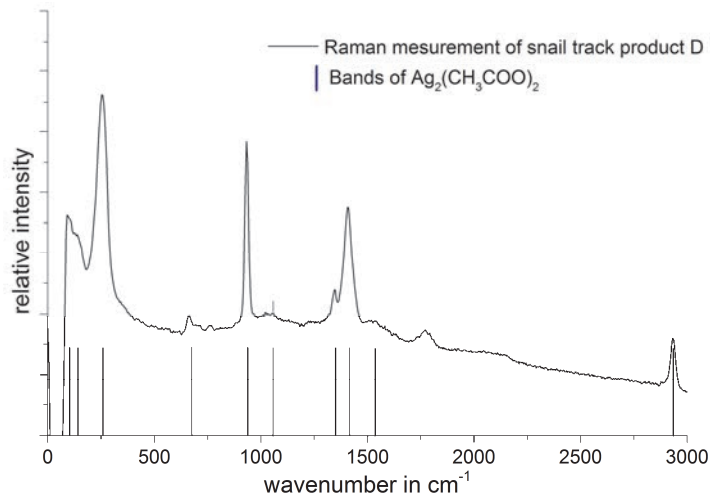
Referring to Fig 2, on the sample (b) silver acetate was detected on the discolored silver grid finger. The Raman measurements of the snail track affected cell is shown together with the bar diagrams of the silver acetate ($\text{Ag}_2(\text{CH}_3\text{COO})_2$), which is abbreviated in the following as Ag_2Ac_2 (“Ac” = Acetate CH_3COO^-), reference measurement in Fig 9.

Fig 9 Raman spectrum of degradation product D at low laser intensity with the main vibrations assigned and the bands given from the silver acetate reference sample.

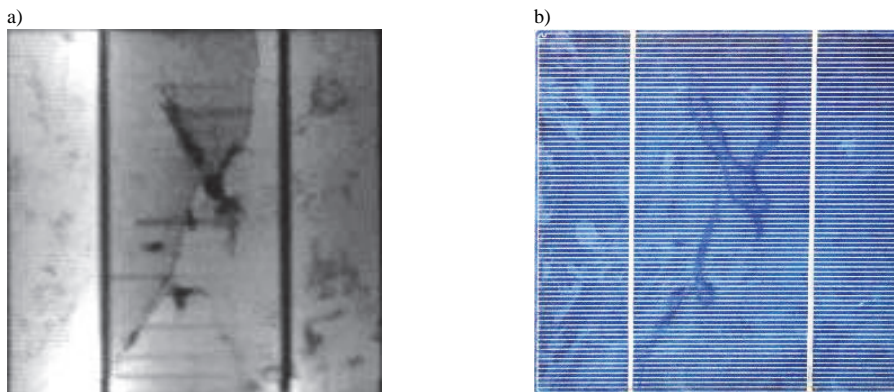
The formation of silver acetate snail tracks on already affected PV modules from the field could be reproduced by exposure to UV irradiation after the induction of new cell cracks. Silver acetate must therefore be formed by the reaction of silver with acetic acid, which is a photochemical degradation product of EVA by the Norrish reaction II. The UV irradiation is most likely not only the source for acetic acid, but also an important activator for the reaction together with oxygen as described for the silver carbonate formation (see section 0). This is additionally supported by the observation that silver acetate snail tracks are most often found for back sheets with high oxygen transmission rates (OTR).

Fig 10 After the induction of new cell cracks and UV testing: EL image (a) and silver acetate snail track affected cell (b)

Fig 10 supports this assumption in an imposing way. The electroluminescence image shows the characteristics of the cell crack (wider cell crack or several cell cracks in parallel = darker, thicker black line). In the area where the cell crack is wider, acetic acid may diffuse out of the module; therefore no silver acetate formation is observable directly on wide cell crack parts. But in some distance to this wider cell cracks, where most likely both the acetic acid formation and the oxygen diffusion from the rear side of the module is still sufficient, the reaction takes place. Therefore, the worm-like, double lined snail tracks appear.
