## ORIGIN AND IMPACT OF CRYSTALLOGRAPHIC DEFECTS IN EPITAXIALLY GROWN SI WAFERS

S. Janz, D. Amiri, E. Gust, S. Kühnhold-Pospischil, S. Riepe, F. Heinz, M. Drießen  
Fraunhofer Institute for Solar Energy Systems (ISE)  
Heidenhofstrasse 2, D-79110 Freiburg, Germany

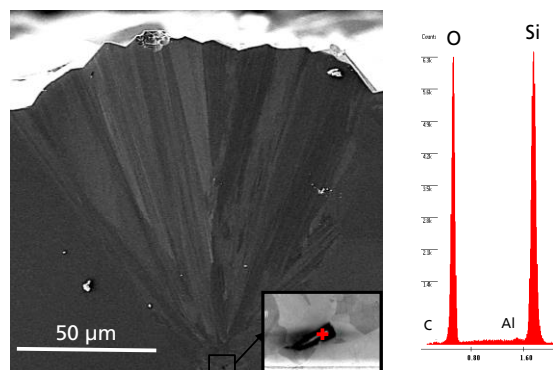
Some of the SFs show poly crystalline inclusions of which some have their origin in particles located at the substrate / layer interface. In Fig.1 one such particle can be found in the SEM micrograph of a respective cross section. Several twin grain boundaries, intercepting crystal planes and the non-oriented structures coming out of the surface plain show the high degree of decoration. EDX measurements presented here (Fig.1, right) identify quartz particles which can be explained by carrier abrasion during movement of the samples. Besides movement related to abrasion at reactor components which are made of e.g. quartz or coated graphites, particles can also arise from gas phase nucleation or parasitic depositions on the reactor walls and then fall on the growth template. Moreover the handling of porosified wafers can be another source of particles or scratches which can influence not just the epitaxial growth but the reorganization process itself.

**Figure 1:** SEM micrograph of a cross section showing a decorated stacking fault (left) with an included particle (inset). EDX data measured at particle position (right) showing high oxygen concentrations which suggest a quartz particle.

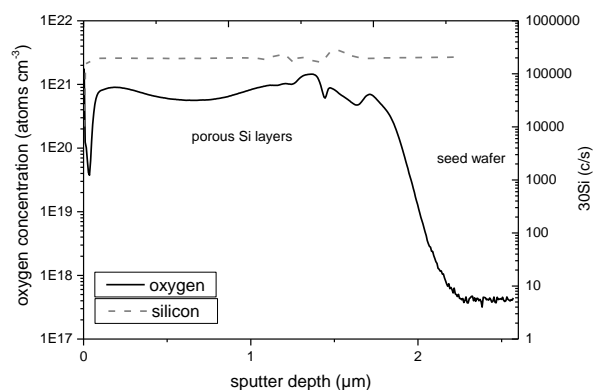
In order to investigate the oxygen concentration in the reorganized porous layer and on its surface we measured such structures with SIMS after hydrogen processing (reorganization). In Fig.2 the SIMS profile from seed wafer to surface (right to left) shows oxygen concentration of up to  $2.1 \times 10^{21} \text{ atoms cm}^{-3}$  in the porous layer. An unwanted oxidation of samples during preparation can be excluded as all samples were broken directly before transferring them to the SIMS chamber. The concentration at the surface is lower than in the porous bulk ( $2.0 \times 10^{21} \text{ atoms cm}^{-3}$ ) and shows a strong dip close to the transition zone between these two. Besides the native oxide growth during shipment, which could not be prevented, the signal accuracy in the first nanometers of the profile is questionable. We therefore cannot finally conclude on the real oxygen concentration on the template. However, as the concentration inside the porous structure is very high oxygen is supposed to play a role in the first layers of Si growth. Finch *et al.* [13] report that oxide can produce steps at the surface forcing the silicon crystal to grow around such an oxide inclusion leading to the formation of stacking faults.

**Figure 2:** SIMS measurement through porous Si layers into seed wafer after reorganization showing oxygen (solid line) and silicon (dashed line) content.

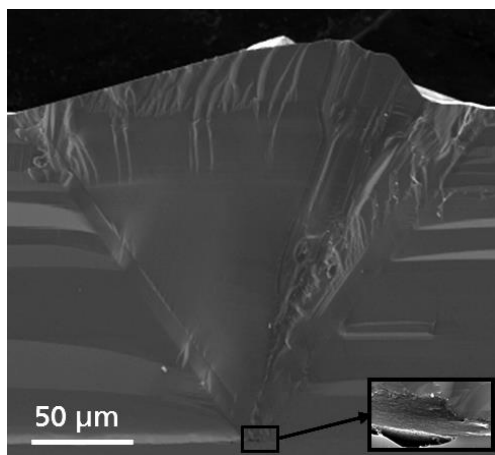
**Figure 3:** SEM micrograph of a cross section showing a partly decorated stacking fault with a locally detached porous Si layer stack (inset) being the origin of the polycrystalline growth.

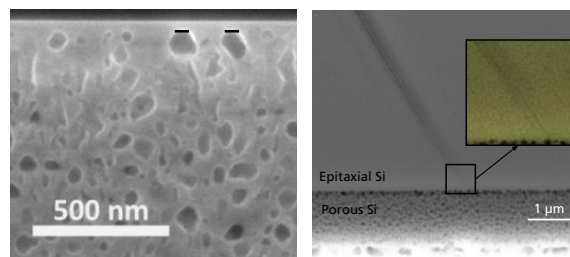
Besides this macroscopic effect of strain on the crystal growth a more microscopic effect has to be considered. In an energetically optimized state all pores should be either spherically shaped or oriented along crystallographically preferred planes. Due to limited energy / time during reorganization and / or residual oxygen on the pore's inner surfaces preventing defect diffusion not a single such perfect pore can be found. However, the pores in proximity to the surface show additional deformations (see Fig.4, left) which look like a

flattening. During reorganization the Si atoms are looking for energetically preferential sites which leads to dissolving of small pores or the growth of the larger ones [15]. The template surface is a pore with infinite size which means that Si atoms want to diffuse there. On the other hand pores in proximity of it tend to close their surface as it is energetically preferential for them. These competition leads to the flattening of the pores which is an energetic compromise leading to microscopic lattice strains in such areas. After epitaxy this strained areas can be identified as the origin for several close parallel faults which grow in the direction on the {111} plane (Fig.4, right).

**Figure 4:** SEM micrograph of cross section showing a reorganized porous layer with flattened pores in close proximity to the growth template (left) and parallel faults originating from one of such pores (right).

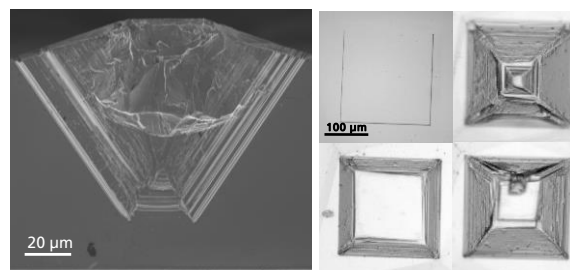
During epitaxy the generated mismatch is compensated through these close parallel faults. In Fig.5 (left) one example for such an accumulation of defects on the fringes of a SF is shown in cross section view. Several variations with an increasing number of close parallel faults can be found in the EpiWafer material. The number of additional growth planes could be explained by different strain levels leading to increased mismatch between crystal structure of template and growing layer. In Fig.5 (right) top views of intersects of the {111} planes with the surface are shown. The increasing number of parallel faults (counterclockwise) caused by increased mismatch / strain leads to pyramidal structures with increasing height.

**Figure 5:** SEM micrograph of defect etched cross section showing close parallel faults along the {111} planes (left). Top view (microscope) of epitaxially grown layers with increasing number of parallel faults (right, counterclockwise).

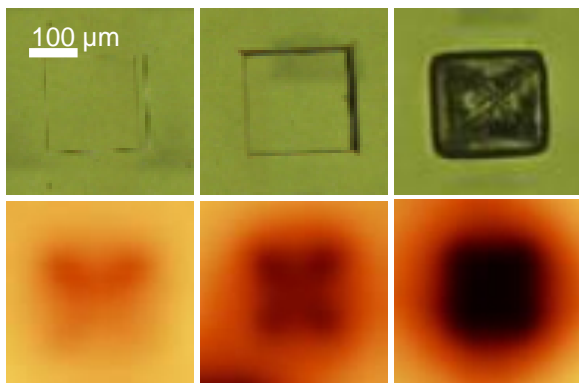
In a first step we identified SFs without and with polycrystalline inclusions (decorated SF) in an optical microscope. On the same spot non-calibrated μPL measurements were performed. In Fig.6 the microscope pictures (top) show a non-decorated SF (left), a SF with some parallel faults (middle) and one filled with polycrystalline inclusions (right). The corresponding

lifetime mappings for the first two show cross like features identifying highly recombination active regions. These cross like shapes overlap with the intersects of the {111} planes which are partial dislocations extending from the nucleation to the surface. It is not surprising though that these regions show enhanced recombination activity. The fully decorated SF seems to be highly recombination active throughout its whole volume. It is not clear so far for all these defects if the decoration with contaminants such as metals or dangling bonds / vacancies is the reason for the high recombination activity.

**Figure 6:** Microscope pictures of top view on epitaxial Si layer (top) and  $\mu$ PL mapping of corresponding regions (bottom).

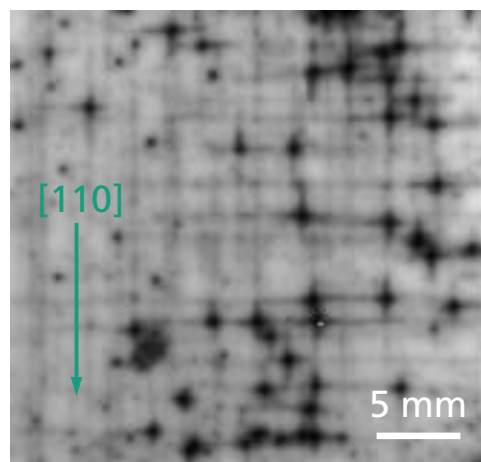
When looking at  $\mu$ PL mappings of larger areas of the EpiWafer we find regions with enhanced recombination (black) following exactly the family of directions  $\langle 110 \rangle$  (see Fig.7). Obviously these lines correspond to another crystal defect. Considering their orientation we conclude that these are line defects which glide along slip planes of the crystal. It is known that such defects occur when the temperature gradient along the wafer is in the range of  $5 - 10 \text{ K cm}^{-1}$  [16] at growth temperature. In most cases they start at wafer edges initiated by little damages. In our case we find that most line defects intersect with SFs. Especially at the crossing points of such slip lines the highly recombination active (decorated) SFs can be found. We came up with two explanations for these effects: (i) After growing an epitaxial layer of  $150 \mu\text{m}$  and more the EpiWafer is exposed to a temperature gradient exceeding  $5 - 10 \text{ K/cm}$  which initiates parallel faults at existing SFs which then glide to the fringes of the wafer. (ii) During reorganization parallel faults are generated again due to thermal process inhomogeneities at micro stress regions in the porous layer itself and glide then along slip lines through the whole template. At the crossings of such line defects step like surfaces can lead to SF growth due to lattice mismatch.

**Figure 7:** PL image of an EpiWafer after detachment showing SF and line defects as highly recombination active areas in black.
