Advanced analysis of backsheet failures from 26 power plants

Jochen Markert*, Sandra Kotterer, Djamel Eddine Mansour, Daniel Philipp, and Paul Gebhardt

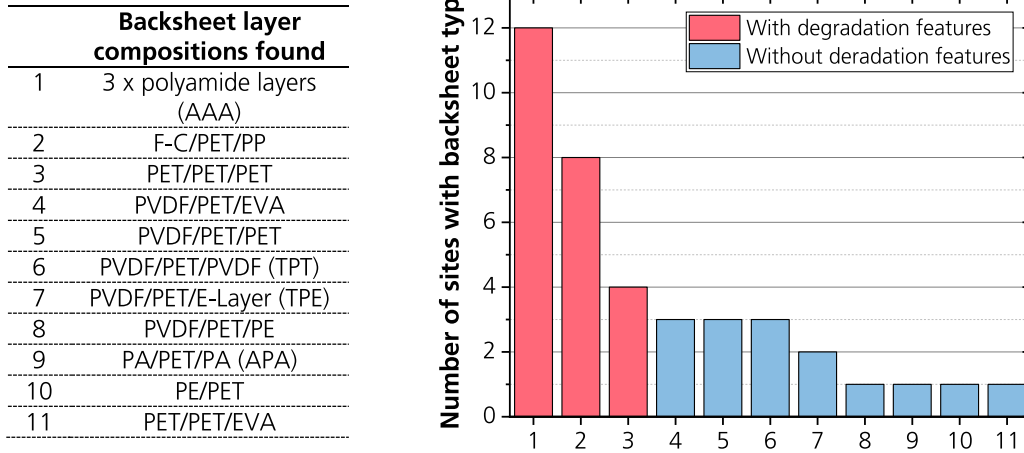
Fig. 1. Left: List of layer structures found in the investigated backsheets; Right: Graph showing the number of sites on which each respective backsheet type was found.

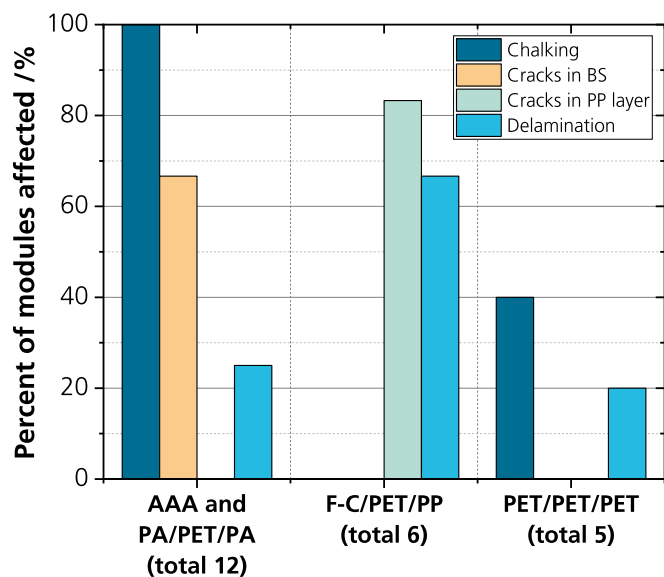
**Fig. 2.** Distribution of the failures in the most relevant degraded backsheet structures after several years of operation.

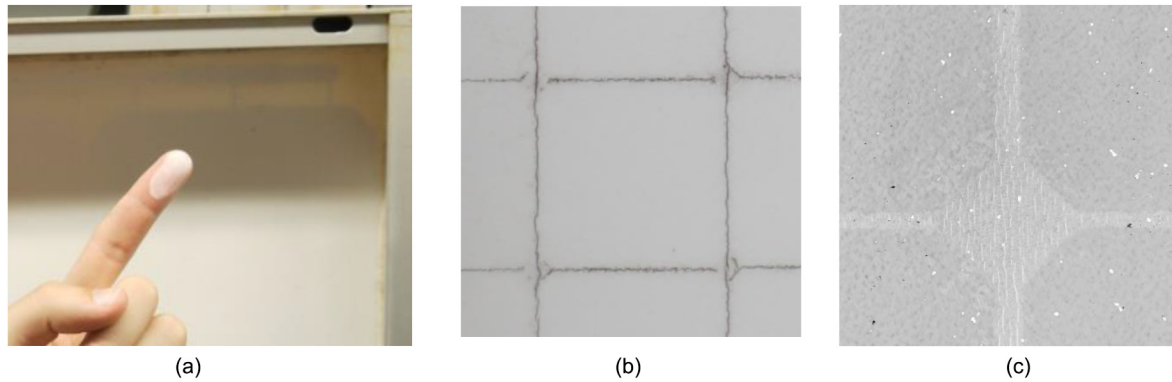
Fig. 3. Images from different degradation features; (a) Chalking on rear side of a polyamide backsheet [9]; (b) Cracked AAA backsheet; (c) Small cracks, indicating a damaged PP layer in a F-C/PET/PP backsheet.

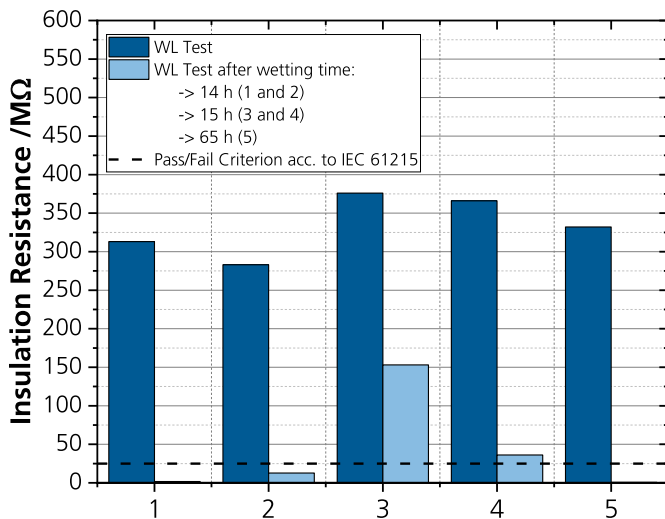
Fig. 4. Wet leakage current test results of five exemplary modules with F-C/PET/PP backsheets from two power plants that have been measured initially and after extended wetting times in a water bath of 14 h (modules 1 and 2), 15 h (modules 3 and 4) and 65 h (module 5).

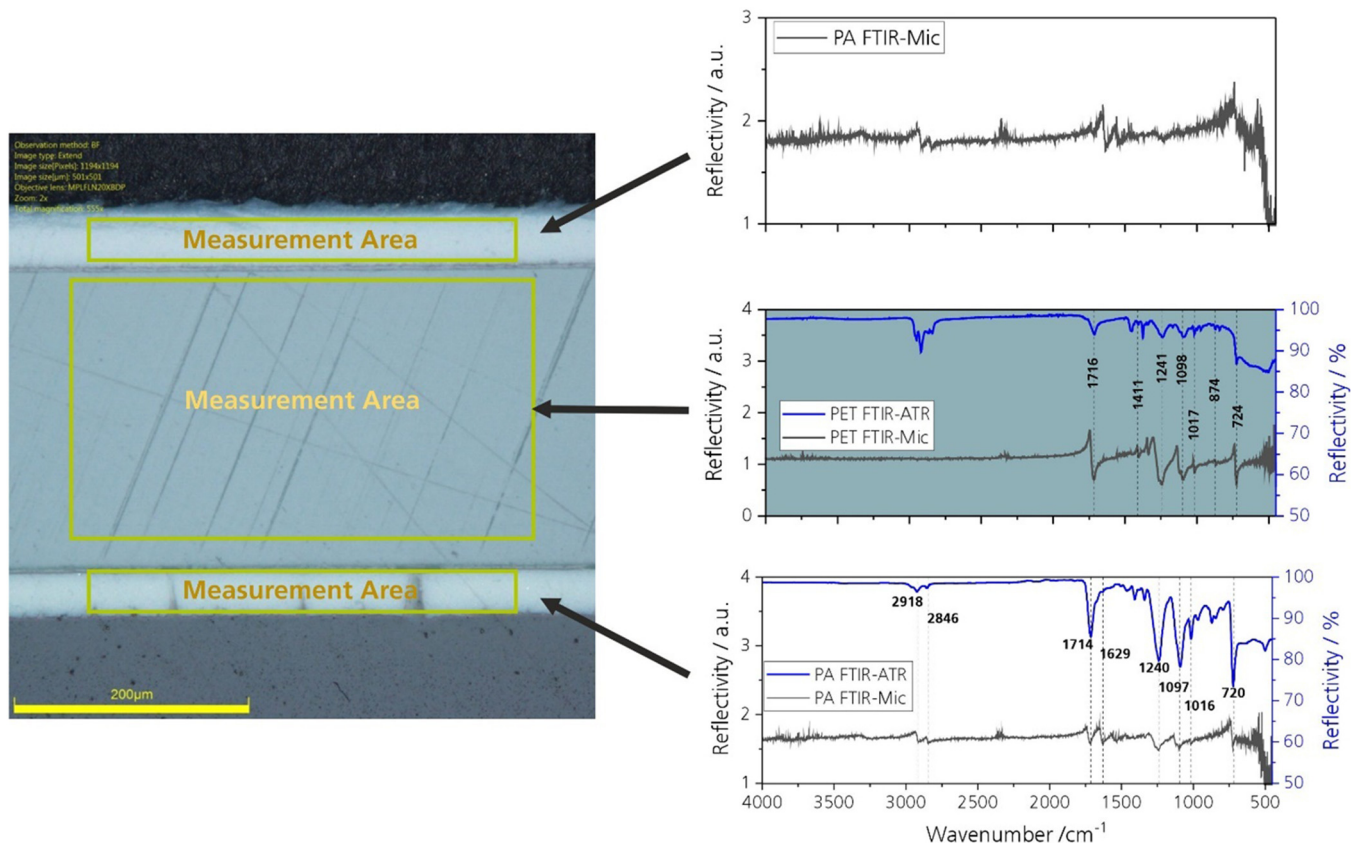
Fig. 5. Left: Microscopy image of the multilayer PA/PET/PA backsheet cross-section in a PV module. Right: Comparison of FTIR microscopy spectra (black) of cross-section samples and ATR-FTIR spectroscopy spectra (blue) of separated backsheet surface layers.

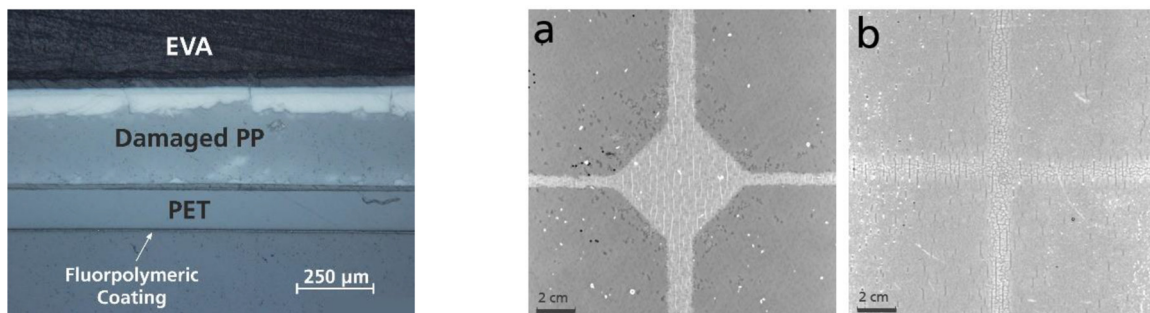
Fig. 6. Left: Cross section of a F-C/PET/PP coating with damaged PP layer. Right: Acoustic images of the multilayer backsheets in a field-exposed PV module; (a) core/inner layers interface of F-C/PET/PP backsheet; (b) outer/core layers interface of PA/PET/PA backsheet.

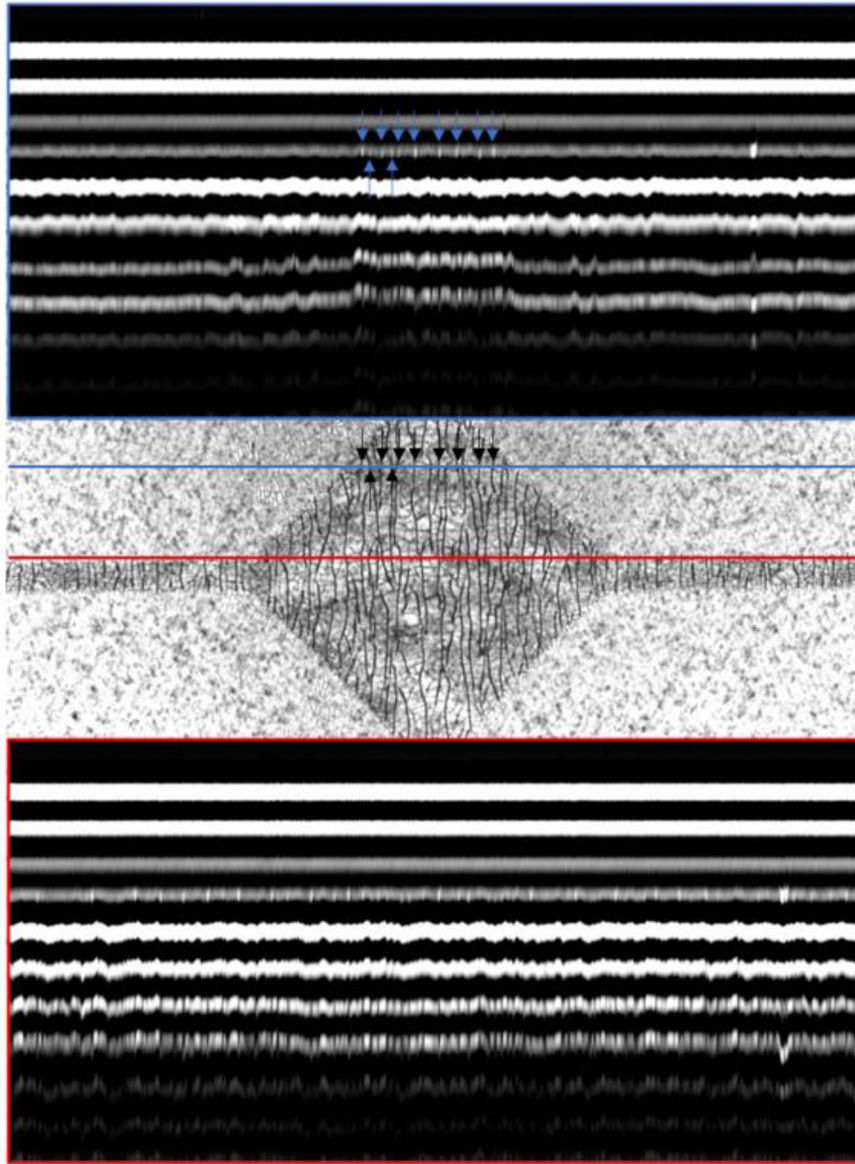
Fig. 7. Acoustic cross-sections of a module with F-C/PET/PP backsheet revealing internal cracks (top and bottom), taken at the lines indicated in the micrograph (middle).

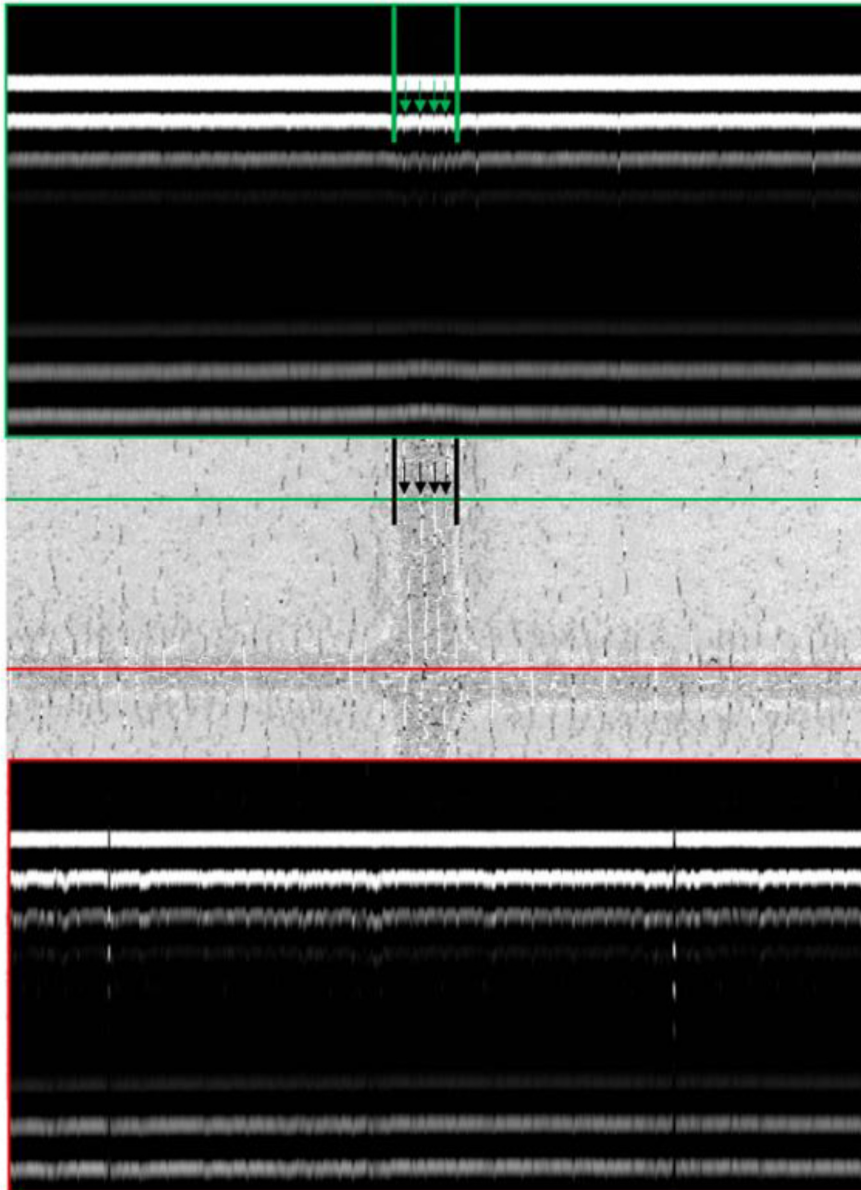
Fig. 8. Acoustic cross-sections of a module with PA/PET/PA backsheet with polyamide outer layer cracking (top and bottom), taken at the lines indicated in the micrograph (middle).
