OPTICAL STRESSING OF 4H-SiC MATERIAL AND DEVICES

B. Kallinger¹⁾, D. Kaminzky¹⁾, P. Berwian¹⁾, J. Friedrich¹⁾, S. Oppel²⁾

¹⁾ Fraunhofer Institute for Integrated Systems and Device Technology IISB, Schottkystraße 10, 91058 Erlangen, Germany

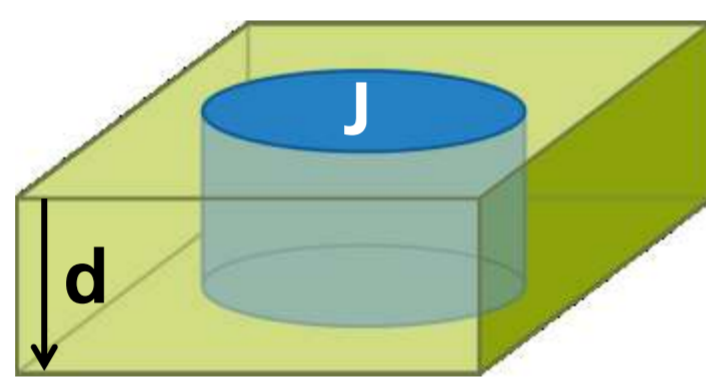
Electrical stress test:

$$\bar{n}_{el} = \frac{J_{el} \cdot \tau}{q \cdot d_{drift}}$$

- Current density $J_{el} = 140 \text{ A/cm}^2$
- Excess carrier lifetime $\tau = 1 \mu\text{s}$
- Elementary charge q
- Drift layer thickness $d_{drift} = 60 \mu\text{m}$

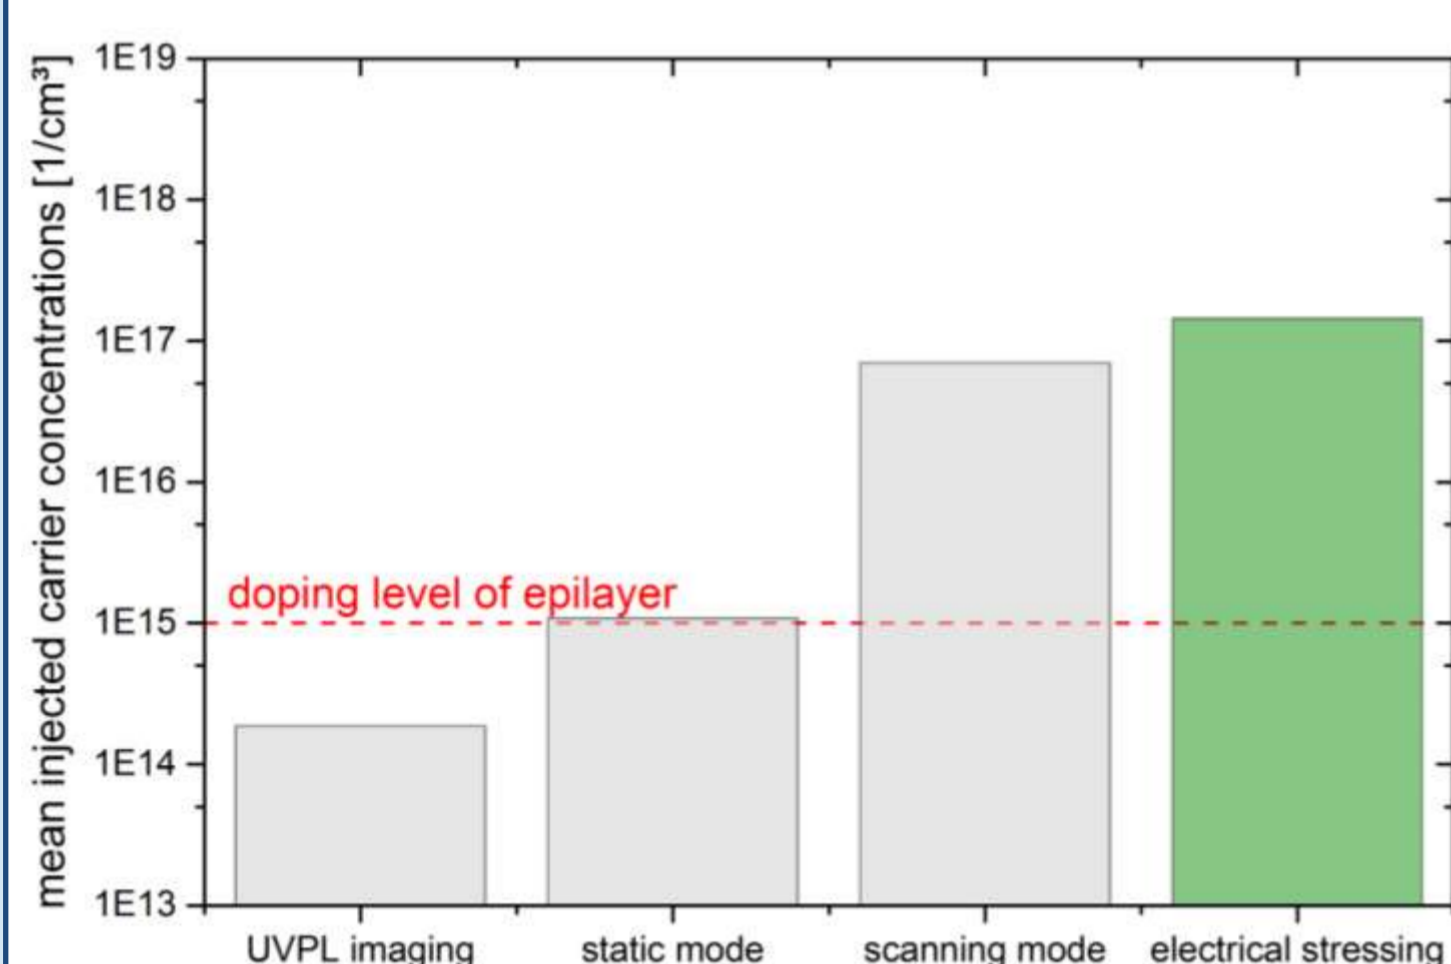
Optical stressing:

$$\bar{n}_{opt} = \frac{J_{opt} \cdot \tau}{d_{abs}}$$

- $J_{opt} = P / (E_{ph} \cdot A)$ with laser power $P = 60 \text{ mW}$, $E_{ph} = 6.1 \times 10^{-16} \text{ mWs}$
- Excess carrier lifetime $\tau = 1 \mu\text{s}$
- Absorption length $d_{abs} = \alpha^{-1} = 7.5 \mu\text{m}$ [3]
- Each photon generates an exciton
- Injection level of
 - scanning optical stress mode ~ electrical stressing
 - static optical stressing ~ doping of epilayer
- UVPL imaging under low injection conditions

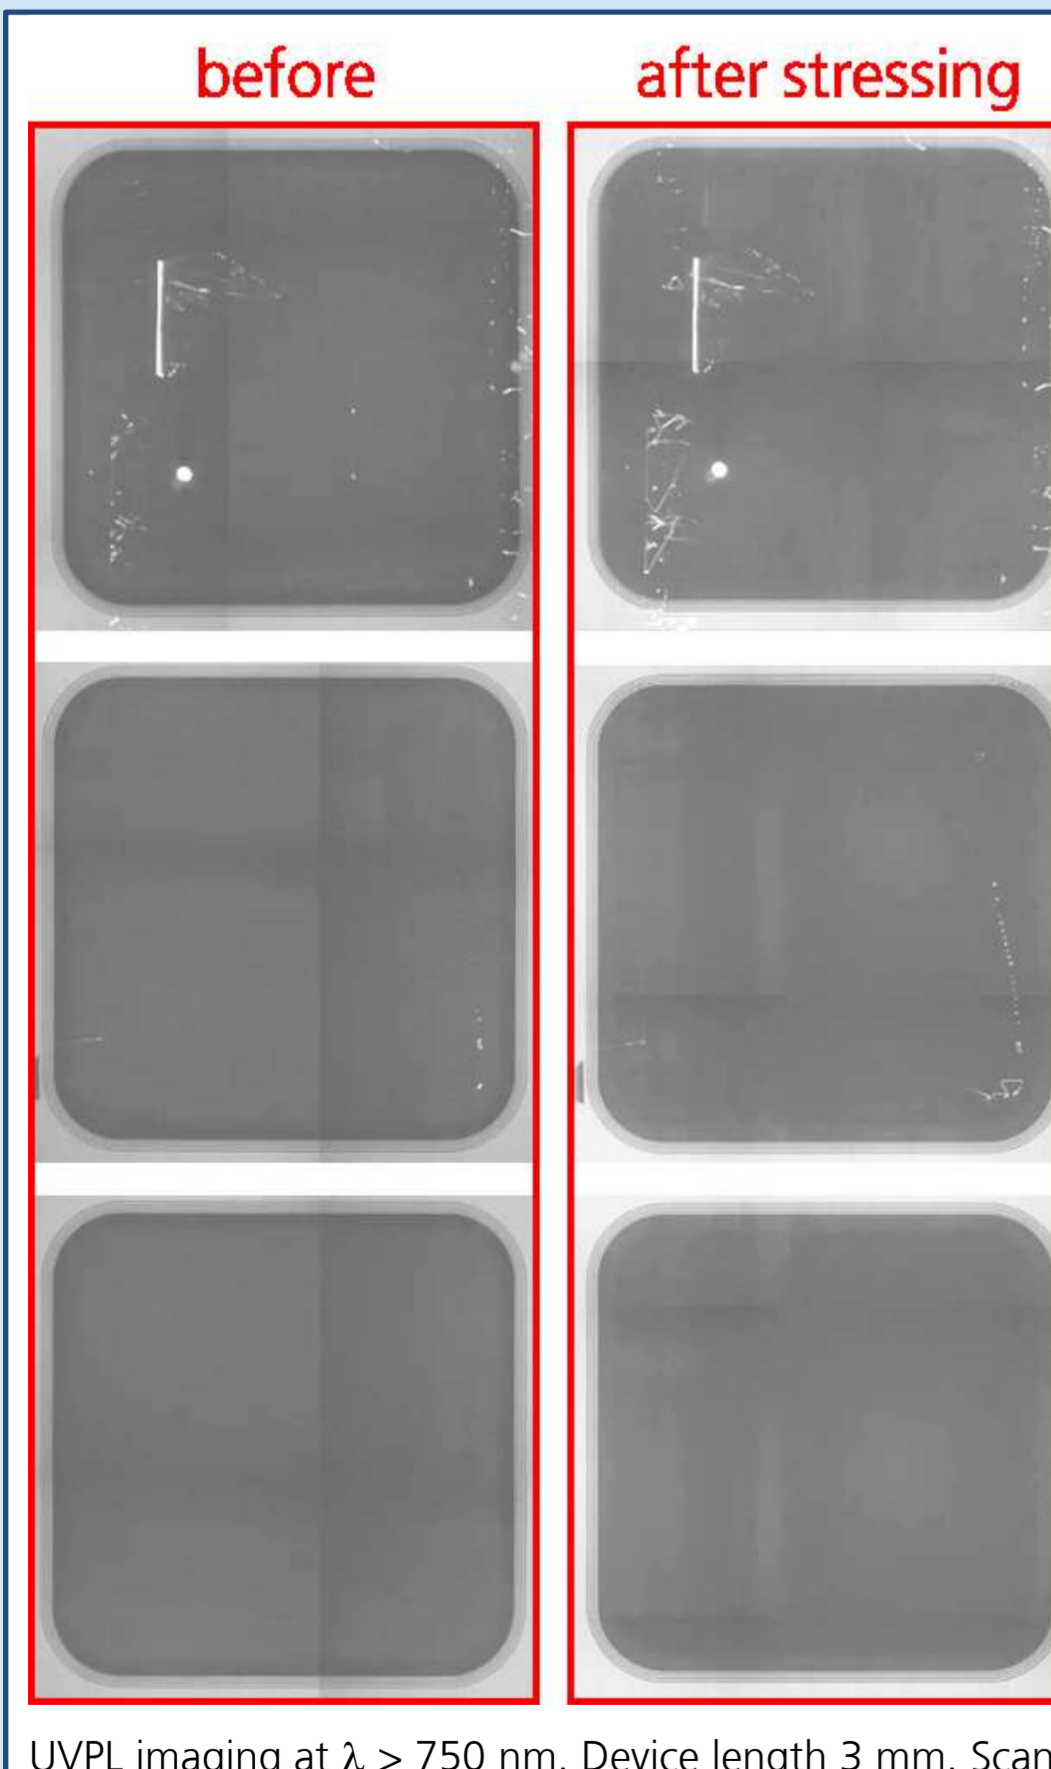
before **after stressing**

Category A: initial BPDs (and other defects) in UVPL imaging

- Defects enlarged due to optical stressing
- **Bipolar degradation can be triggered optically in a very short time**

Category B: some initial BPDs, hardly visible in UVPL imaging

- Defects enlarged due to optical stressing
- **Improved identification of defective / defect-free devices**

Category C: no BPDs visible, but truly reliable?

- No change by optical stressing (within top region)
- Free of defects in deeper areas? → other wavelength
- **No bipolar degradation**
- **Device reliability tested optically**

UVPL imaging at $\lambda > 750 \text{ nm}$. Device length 3 mm. Scan speed 100 $\mu\text{m/s}$ at 500 μm beam diameter → 30 sec/line, 6 lines per device = 180 sec/device.
