LONG-TERM PERFORMANCE OF EXTERNAL THERMAL INSULATION SYSTEMS (ETICS)

Helmut Künzel, Hartwig M. Künzel, Klaus Sedlbauer

Fraunhofer-Institute for Building Physics, Holzkirchen, Germany

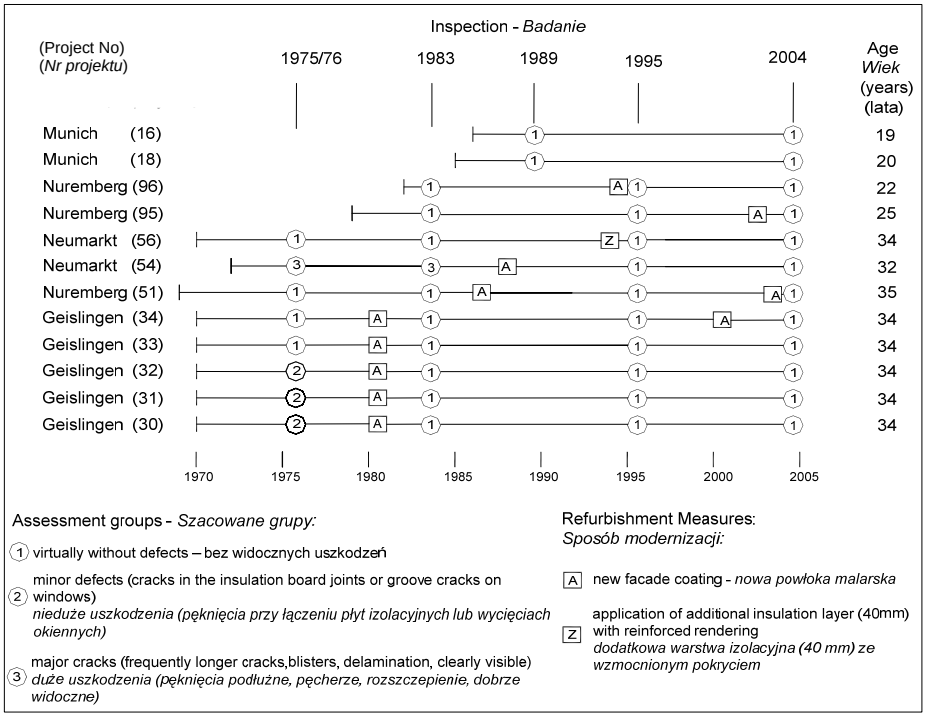
The investigated objects together with details regarding location, the type of applied External Thermal Insulation Composite System (ETICS), data on the building and refurbishment measures are indicated in Table 1. The diagram in Figure 1 shows the times of ETICS application, inspection and the assessment of the state. As a result the following may be deduced:

Fig. 1. Diagram showing the times of application, inspection and refurbishment of External Wall Insulation Systems in practice with notes on the state of the façades classified by means of the assessment groups specified above

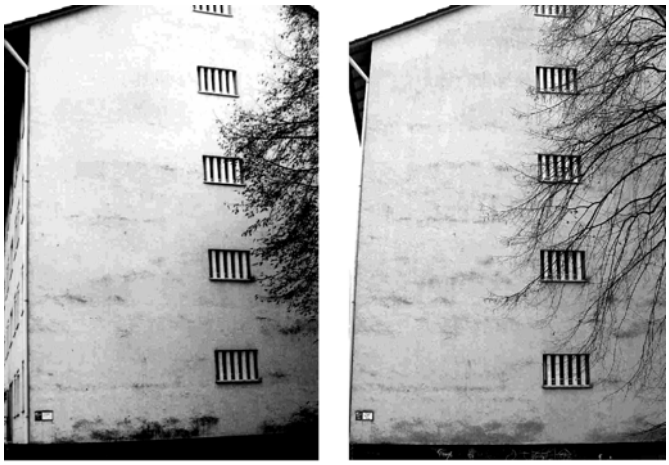
Figure 2 shows the northern façade of object 52 (residential building in Geislingen) at three different times. Despite variations in the quality of the photographs, no important or harmful change is to be observed over a period of 23 years. On the western sides of parallel located residential buildings in Geislingen (objects 30 to 33), however, partial development of algae has occurred. It is remarkable that the algae growth did not change within the period between the two inspections (Fig. 3). The neighbouring object,

Fig. 3. Western gable side of object 31 in Geislingen 14 years (left) and 23 years (right) after refurbishment in 1981 with algae growth in the plinth area and some horizontal stripes, caused by irregularities in the plaster structure in relation with the working levels of the scaffold. The tree has grown visibly; the algae infestation remained unchanged with a slight increase in the upper façade area

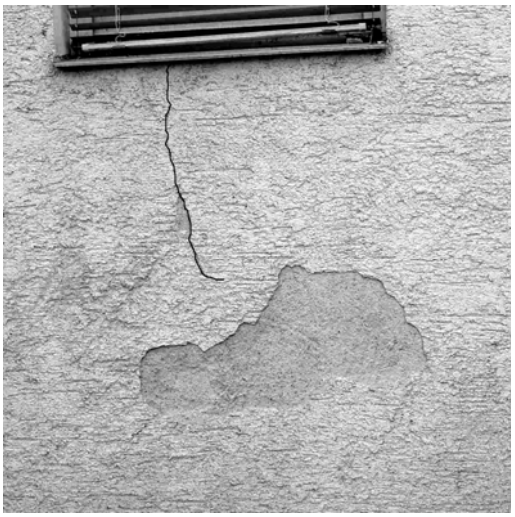
Fig. 8. Crack in the wall and damage of plaster on the western façade of the neighbouring building of object 32 without an External Wall Insulation System (Ebertstraße 2). A crack in the wall below the window is occurring in the plaster. The final rendering has partially separated from the undercoat plaster. Such damage can generally be avoided by means of a thermal insulation composite system with the help of the de-coupling effect of the soft insulation layer as well as plastic additives and the reinforcement of the plaster
