THERMOGRAPHY ASSISTED CHARACTERISATION OF PRODUCTION-INDUCED DEFECTS IN CFRP AND THEIR INFLUENCE ON THE MECHANICAL BEHAVIOUR

ABSTRACT: A novel hybrid-joint, suitable to series production, is currently developed. It overcomes the gap in stiffness by inserting a thermoplastic element between metal and carbon fiber reinforced polymer (CFRP). The main goal in terms of quality assessment is to characterise the defect-caused damage propagation (effects of defects) by means of destructive and non-destructive testing (ndt) of artificially implemented defects.

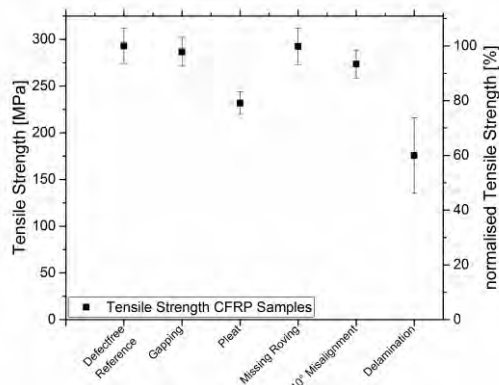
Fig. 2 Tensile Strength of tested CFRP Samples, right scale: tensile strength normalised to the defect-free reference

Fig. 2 reveals that gapping and missing roving have almost no effect on the tensile strength, since the deviation referring to the reference is less than

the scattering. In contrast to that, the pleat and the 10° misalignment caused a drop of 20 % and 5 %, respectively. The most crucial attenuation can be found for the delamination, whose tensile strength reaches only 60 % of the reference strength. It can be further noted, that higher scattering resulted for samples containing delamination.

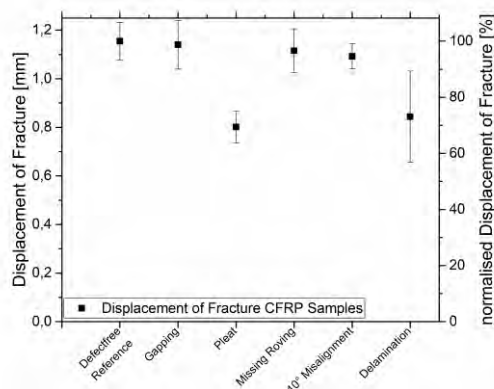
The similar tendency can be found for the displacement of fracture, which is shown in Fig. 3. Deviation caused by gapping and missing roving lie within the scatter of the reference. A slight decrease can be observed for 10° misalignment whereas pleat and delamination cause a drop of approximately 25 %.

Fig. 3 Displacement of fracture of tested CFRP, right scale: displacement of fracture normalised to the defect-free reference

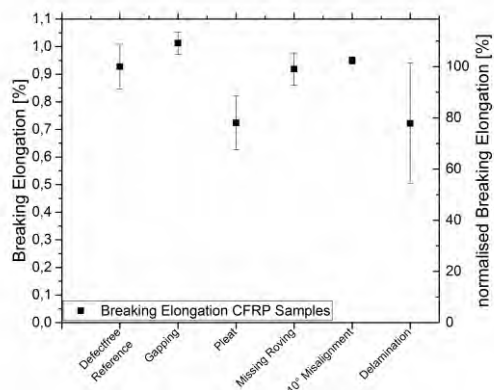
Figures 4 and 5 show the results for the breaking elongation and E-moduli, respectively. As observed for the tensile strength and the displacement of fracture, the missing roving remains effectless. In the case of gapping and 10° misalignment the breaking elongation is even higher than the reference value, which can be attributed to an equivalent drop in E-modulus.

Fig. 4 Breaking elongation of tested CFRP Samples, right scale: breaking elongation normalised to the defect-free reference

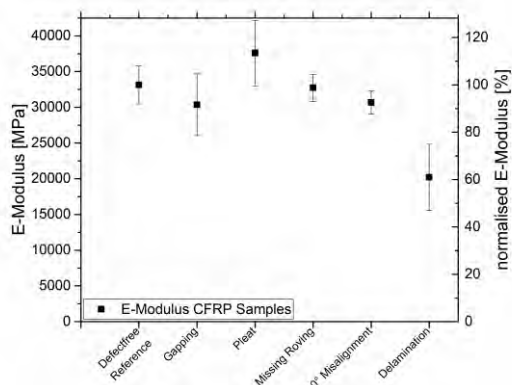
Contrary effect is evident in the case of pleat, for which the E-modulus was found to be 113 % of the

reference value, corresponding to a 20 % drop in breaking elongation. It has to be noted, that the E-modulus of the sample with pleat is only valid preliminary to the first occurrence of damage, where the pleat opens and nonlinear behaviour follows.

Serious weakening of the material by delamination is indicated by means of serious drops in both, stiffness and breaking elongation of 40 % and 21 %, respectively.

Fig. 5 E-Modulus of tested CFRP Samples, right scale: gives the E-Moduli normalised to the defect-free reference

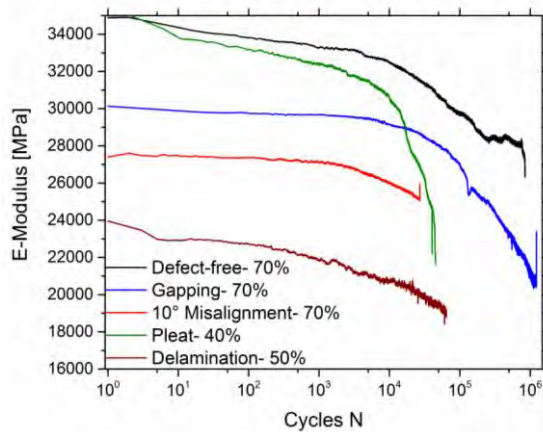
Additionally, the representative development of the E-moduli is shown in Fig. 8.

Fig. 8 Development of E-moduli during fatigue testing, legend gives different relative displacements

Along the defect-free samples most resisted the loading for more than 10^6 cycles, whereas some broke earlier. Therefore higher scatter could be found. The samples with gapping survived almost the same amount of cycles but with lower scatter. Though higher degradation of the E-modulus, which corresponds to the scalar damage factor [12], is evident in Fig. 8 for cycles higher than 10^4 . For specimens with 10° misalignment, subjected to a relative displacement of 70 %, the average lifetime being 54000 cycles, lowest degradation previous to fracture could be observed.

The lifetime under fatigue conditions was more sensitive to pleat and delamination, as the average lifetime showed a significant drop for those defects (see table 1). This is confirmed by Fig. 8, as the delaminated specimens suffered significant degradation within the first cycles. Moreover the highest degradation rate appeared at the gapping. A possible reason could be a change in the damage mechanisms which results in accelerated damage propagation.

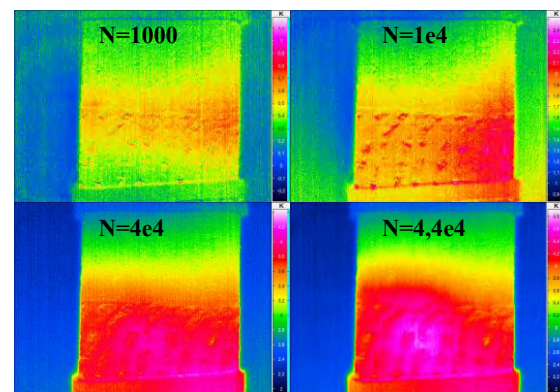
Fig. 10 Differential temperature image of delaminated samples, corresponding to Fig. 8 at $N=10^3, 10^4, 4 \cdot 10^4, 4.4 \cdot 10^4$

It can be seen in Fig. 10 that the pleat causes primary temperature increase surrounding the pleat at low cycles. Therefore significant deformation can be assumed in the disturbed region, which results

in the formation of a hot spot at medium cycles ($<10^4$). Subsequently the evolution of a dominant hot spot, ending in final failure, is observed, which fits well to the predominant rapid stiffness degradation in Fig. 8, starting at approximately 2000 cycles.
